CAFO WPDES Compliance Report (10-30-09)

Inspection date: October 15, 2009

Inspection type: Permit reissuance

Operation Name: Dairyland Farms LLC

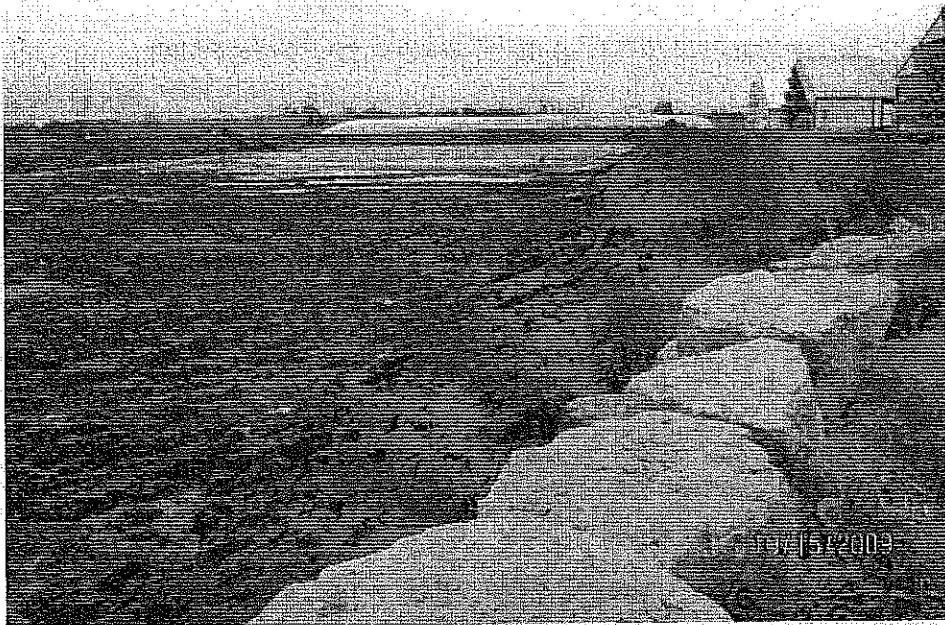
The Dairy Center facility is well maintained—surrounding drainage ditches are mowed and wheat straw bedding is kept in silage bags. Manure levels were below margin of safety and storage appears to be in good condition. Dufek indicated that Dan Davister is in charge of weekly inspections of the storage which are recorded in the CAFO Calendar. Davister indicated he walks the perimeter of the storage and has repaired rodent holes by filling with a combination of gravel and dirt. Manure storage does not have fencing in place—fencing a minimum of 4 feet high needs to be installed.

Looking south at earthen manure storage.

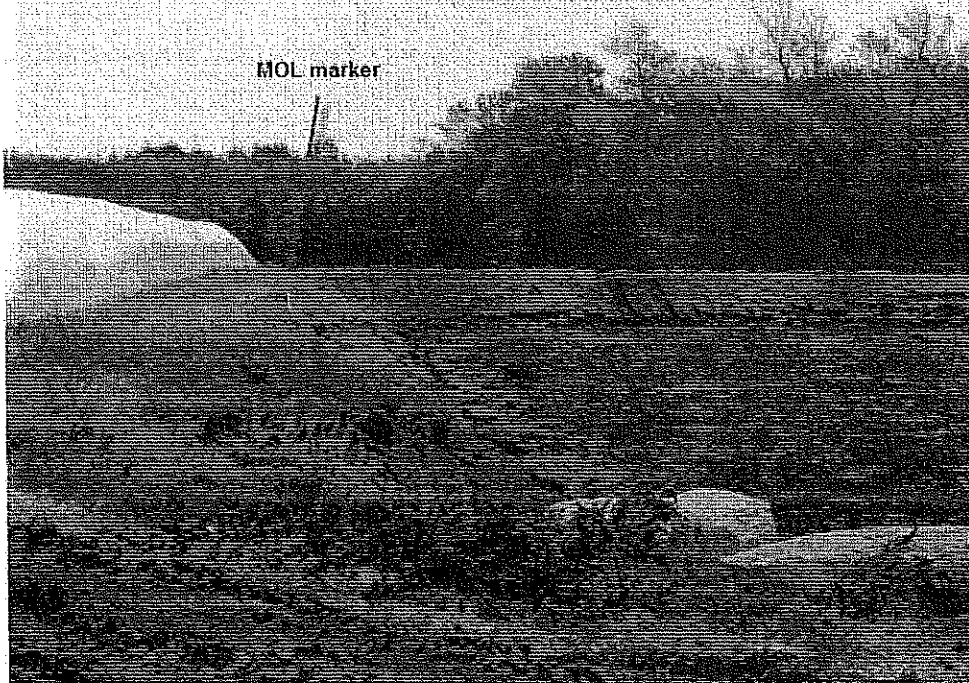
Looking east at north side of storage.

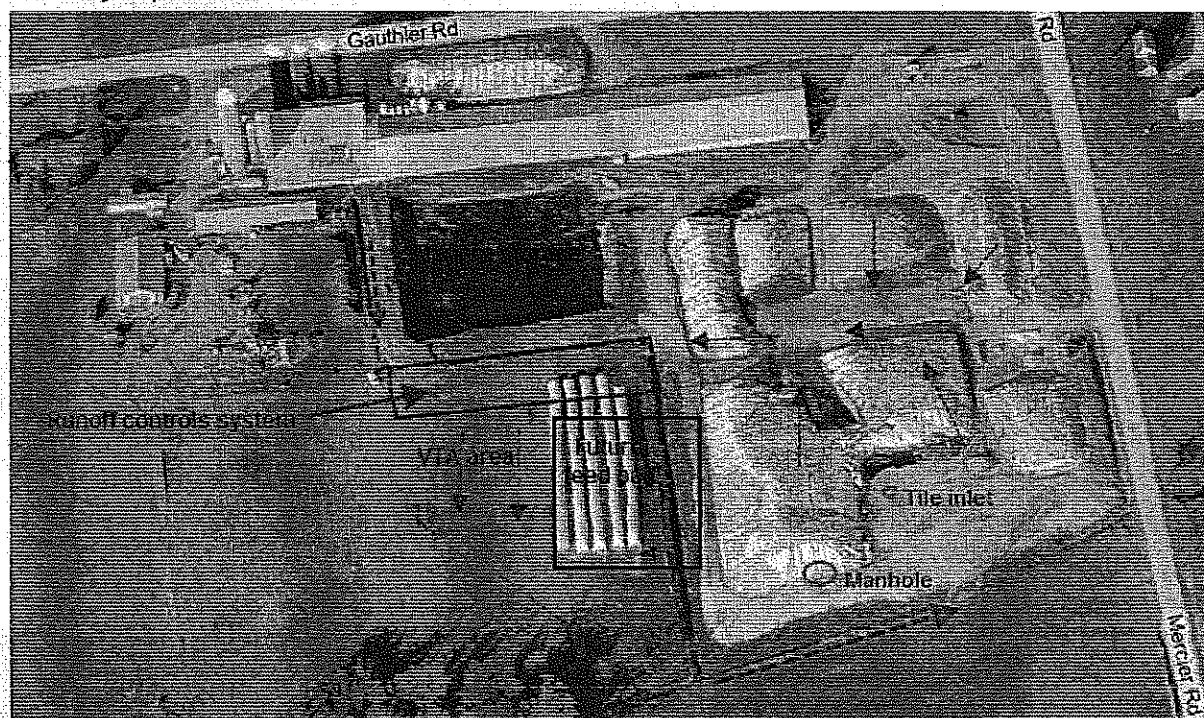
This location houses the older dairy cows and has a large feed storage area and earthen manure storage. Phase one of constructing the feed leachate collection system was nearing completion at time of inspection. Phase two which consists of establishing the vegetated treatment area (VTA) will occur in spring of 2010. According to Dufek there are tile lines under the concrete feed pad. Dufek stated entire pad drains to central location and will flow into the constructed collection system. Dufek showed Jones the tile inlet and manhole along the south side of the feed storage pad that is intended to collect runoff and carry to collection system. A more defined earthen berm along the entire southern edge of the feed pad should be graded and stabilized to help divert all runoff to collection system and ensure a discharge to the stream tributary is prevented.

Weekly inspection of the feed storage area runoff system will be required in reissued permit. Tile inlets and manhole need to be cleared of solids to prevent clogging.

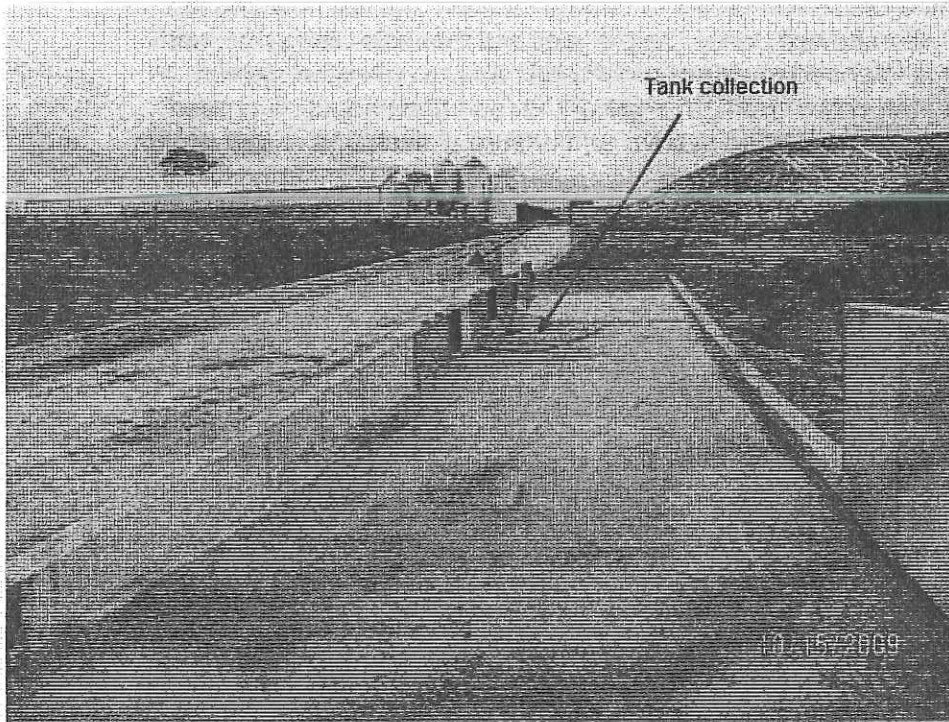
Looking east at recently constructed runoff controls for feed storage area. VTA will be to south.

Jones told Dufek a set of as-built drawings to show complete construction documentation of the feed leachate collection system that includes a map of drain tile system will need to be submitted after completion of project. Dufek stated that installing a secondary settling basin within the VTA area is an option if the VTA does not support the volume of storm water runoff.

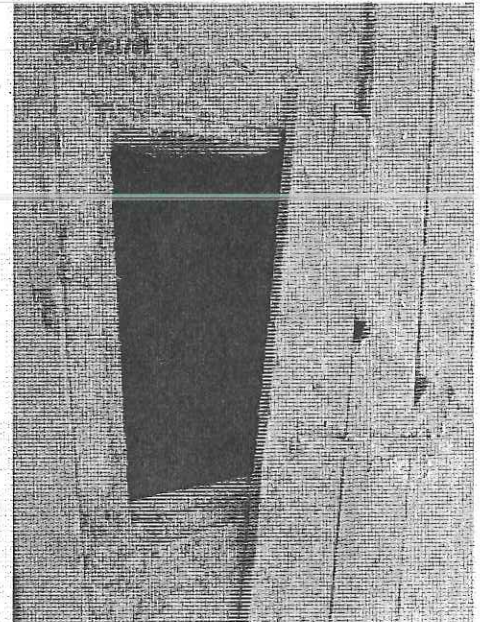
Close-up of tank collection.

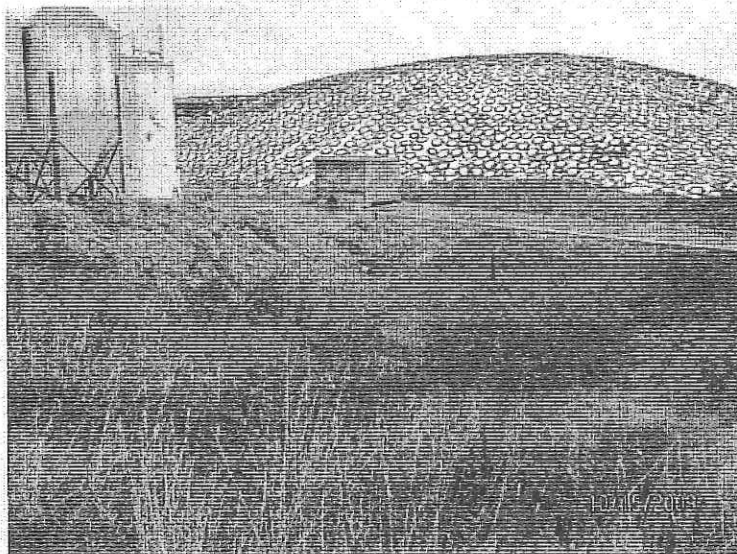
Above: Looking southeast, ditch in foreground will be filled in to divert all runoff to concrete collection system.

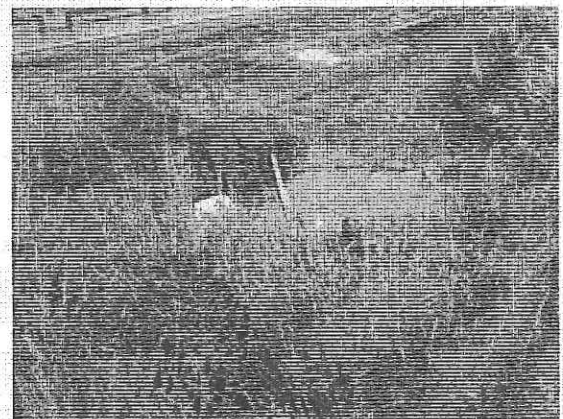
Right: Photos show temporary collection system that had been in place, leachate was pumped from ditch to storage.

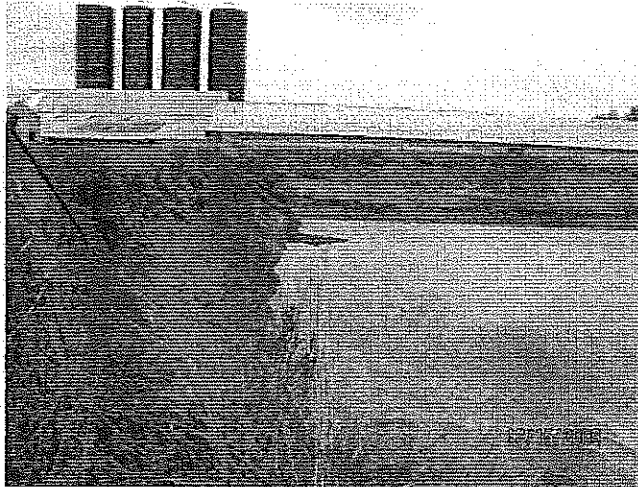
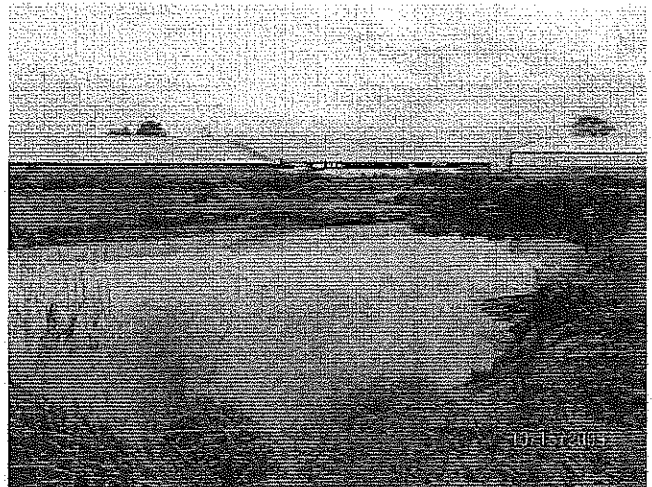
The earthen manure storage at the Home Farm was constructed in 1992. The permit compliance schedule requested a full evaluation of this structure be completed by September 30, 2005; after file review, a Department letter dated May 19, 2005 provided as-built review comments of this structure that indicate further evaluation was not required. However, because the storage was constructed to an outdated standard and will soon be receiving a large volume of liquid content from the leachate collection system a written evaluation discussing this issue and including storage capacity calculations needs to be included in the permit application package. Fencing also needs to be installed around this storage. Photos below.

Looking north at manure storage.

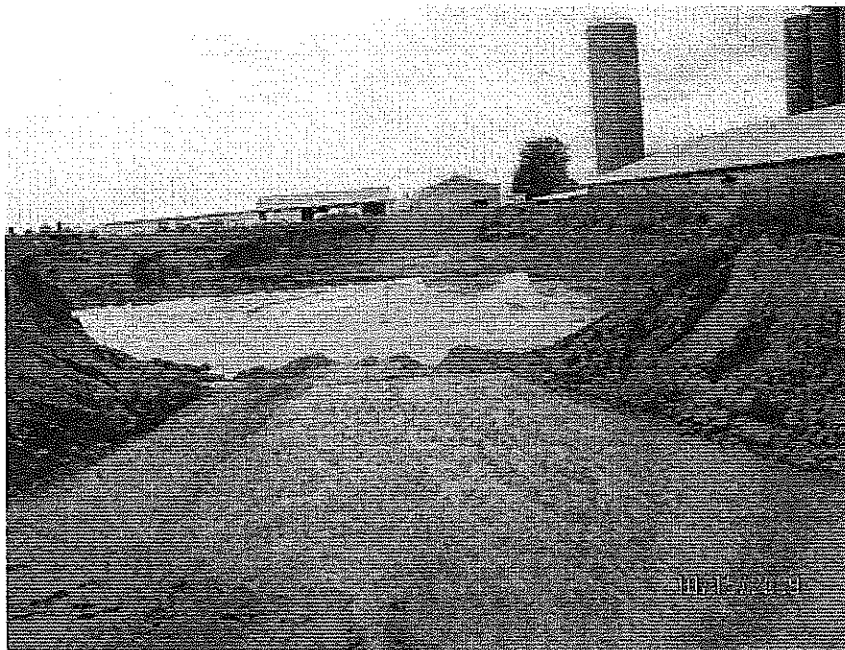
Looking west at concrete ramp into storage.
